CLEVELAND STREET

Decluttering audit

Decluttering Cleveland Street

BETTER STREETS AUDIT

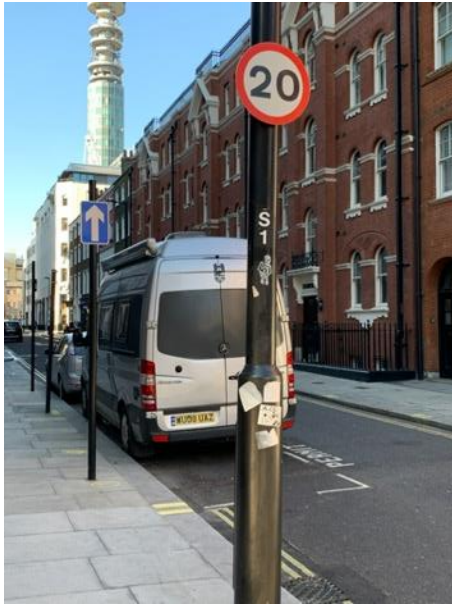
LOCATION: Immediately north of Mortimer Street.

ISSUES: Unnecessary sequence of signage poles. These could be reduced to a single pole for the kerbside restrictions, speed limit and directional signage. The one direction sign also repeats an earlier one, above the 20 mph sign shown in the photo, therefore is unnecessary.

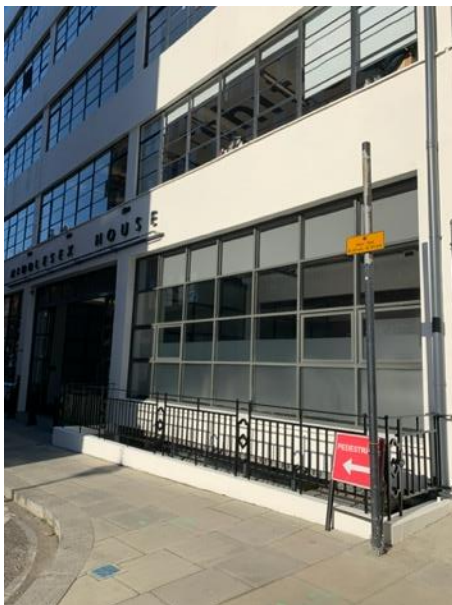
LOCATION: Outside Middlesex House.

ISSUE: Superfluous no waiting sign outside zebra crossing. Pole and sign could be removed. Remove the temporary pedestrian directional sign. The zebra crossing markings have worn therefore could benefit from being re-marked.

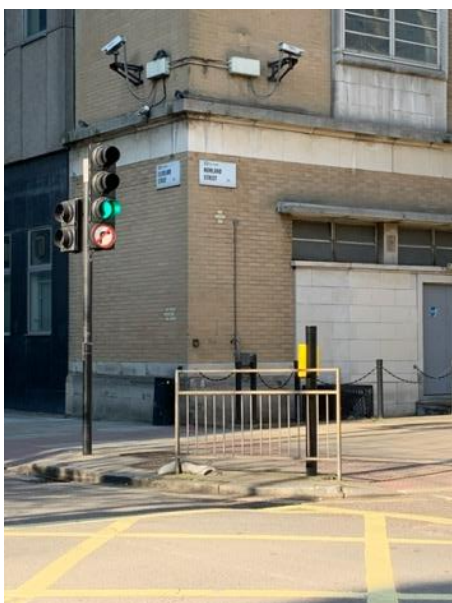
LOCATION: Junction of Howland Street and Cleveland Street.

ISSUE: Unnecessary guard railing, which should be removed.

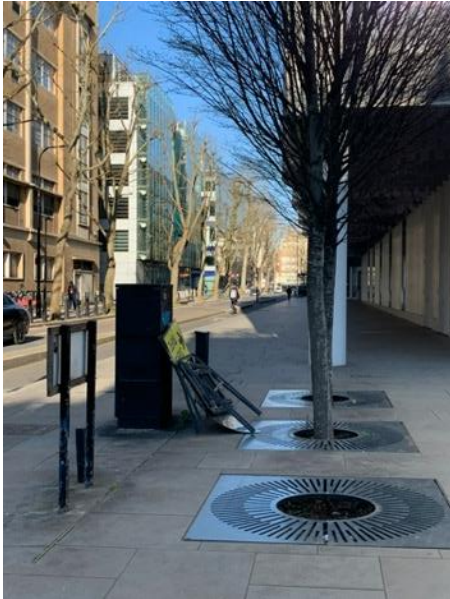
LOCATION: Junction of Howland Street and Cleveland Street.

ISSUE: Missing tree from existing tree-pit, which needs to be replaced.

Abandoned temporary street signs, which need to be removed.

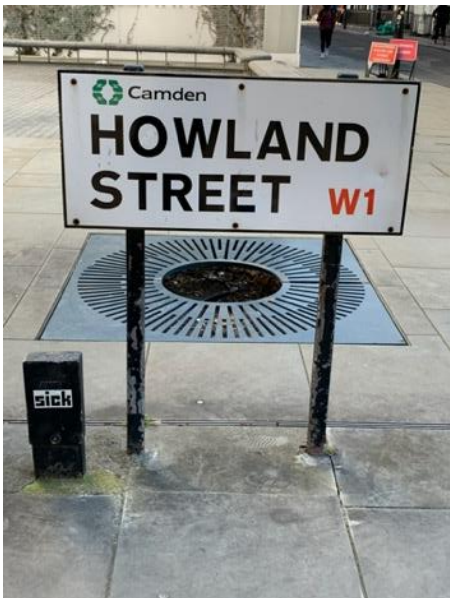
LOCATION: Junction of Howland Street and Cleveland Street.

ISSUE: Unnecessary street signage, which repeats street signs on nearby buildings. This sign could be removed.

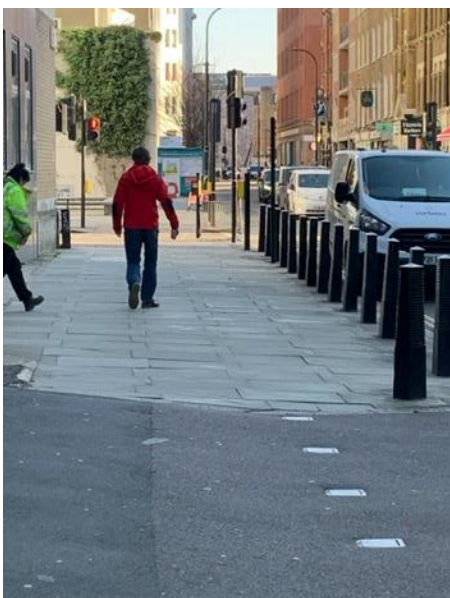
LOCATION: Eastern side of Cleveland Street, north from Howland Street, next to the BT Tower.

ISSUE: A cordon of bollards surround the BT Tower. This image illustrates that a hostile vehicle still could enter the footway next to the BT Tower. Although a full security assessment has not taken place as part of this study, the bollards do not appear to be of the standard necessary to protect infrastructure from an attack. It is recommended that Camden Council and BT review the purpose and need for the

current bollards; and seek to either remove or replace them with a blend of more suitable and elegant protection measures, such as HVM planters and seating.

The footway is also wide enough in this location to accommodate additional cycle parking, which could be considered as part of a review of the bollards.

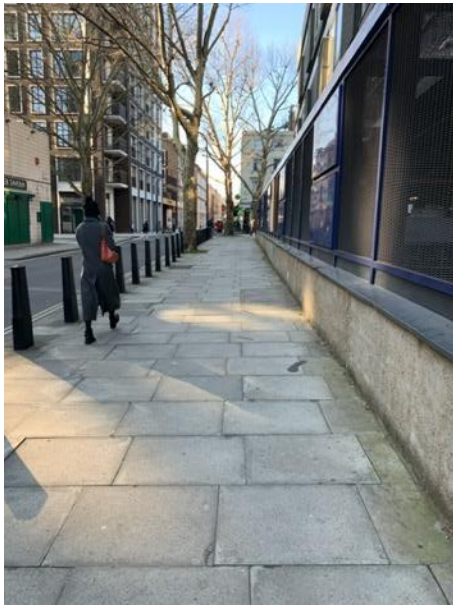
LOCATION: Eastern side of Cleveland Street, next to the BT Tower.

ISSUE: As above, a cordon of bollards surround the BT Tower, which seem to serve no functional purpose.

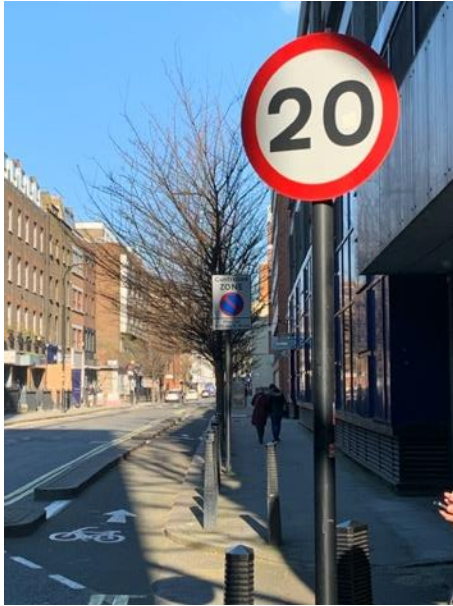
LOCATION: Maple Street, junction with Cleveland Street.

ISSUE: The requirement for a dedicated pole for each street sign in this location needs to be reviewed.

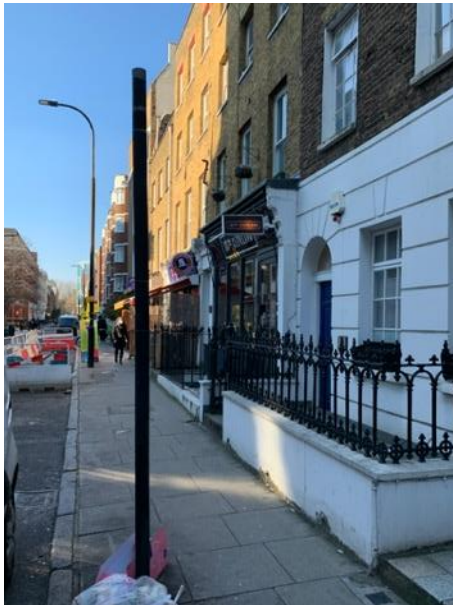
LOCATION: Between Maple Street and Howland Street.

ISSUE: Pole without signage, therefore potential to be removed.

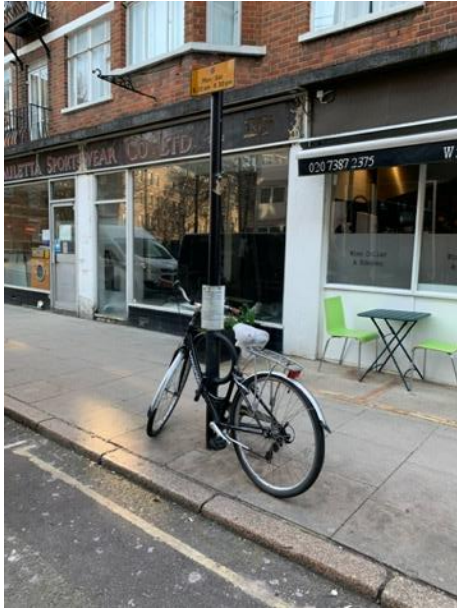
LOCATION: Cleveland Street, north of Grafton Way.

ISSUE: Unnecessary repetition of signage posts, which are also being used for cycle parking.

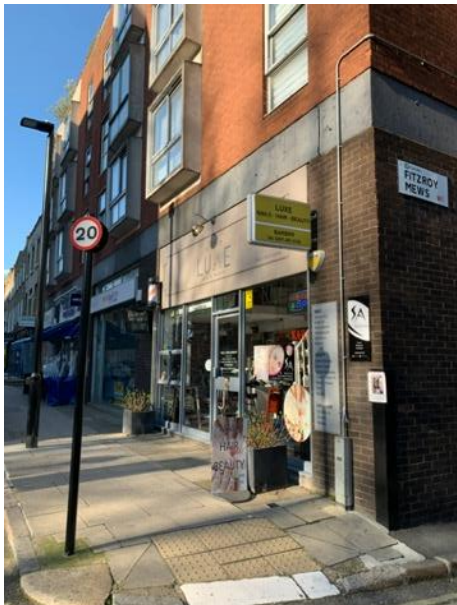
LOCATION: Cleveland Street, north of Fitzroy Mews.

ISSUE: Unnecessary signage poles. Speed limit sign could be positioned on nearby street light column.

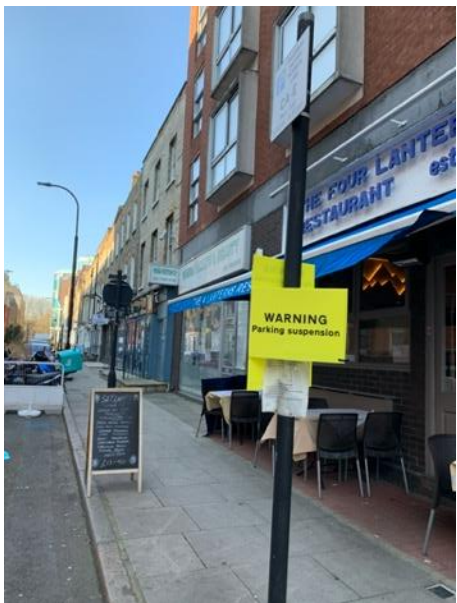
LOCATION: Cleveland Street, north of Grafton Way.

ISSUE: Unnecessary repetition of kerbside uses signage poles. These signs could be repositioned on nearby pole, adjacent to the A board.

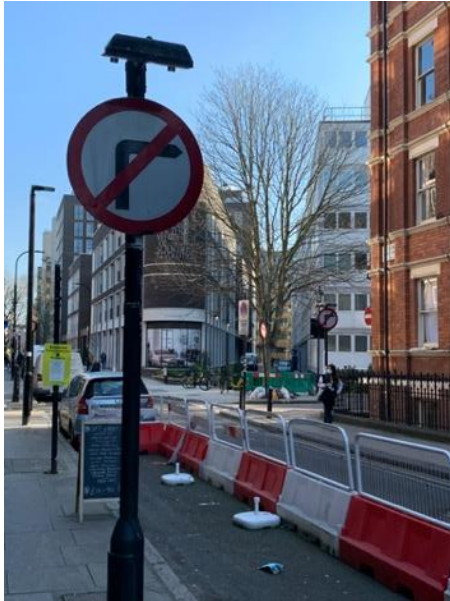
LOCATION: Cleveland Street, junction with Carburton Street.

ISSUE: Unnecessary repetition of no right turn and no entry signs. Unnecessary protective bollards. This space could be decluttered of redundant street furniture to create space to extend the existing cycle parking (WCC side).

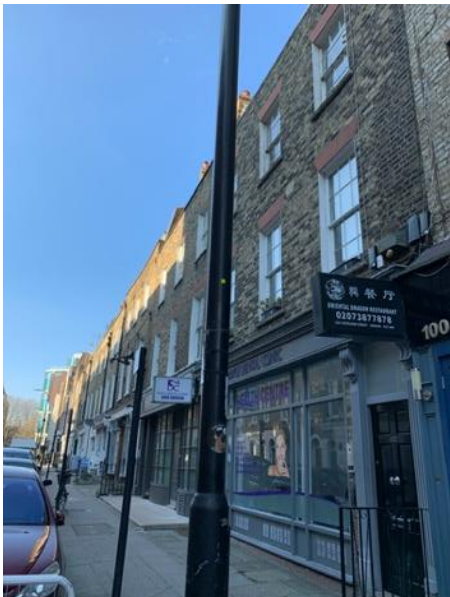
LOCATION: Cleveland Street, north of Grafton Way.

ISSUE: Unnecessary repetition of kerbside uses signage poles (same issue as above). These signs could be repositioned on nearby pole, adjacent to the A board.

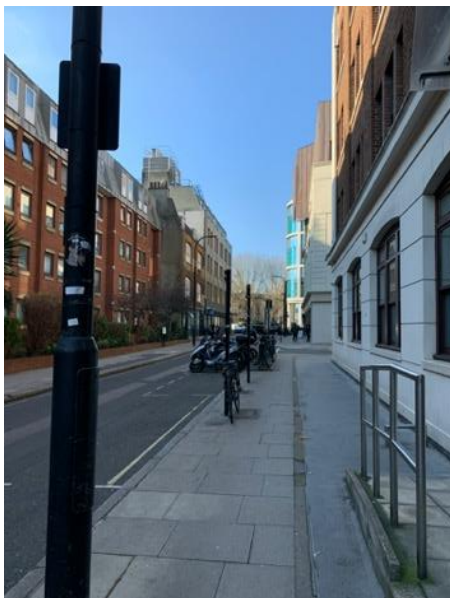
LOCATION: Grafton Way to Warren Street eastern side.

ISSUE: Repetition of poles for kerbside restriction signs. These could be reduced in number by placing more than one sign on each pole, with a directional arrow to indicate the location of kerbside restrictions.

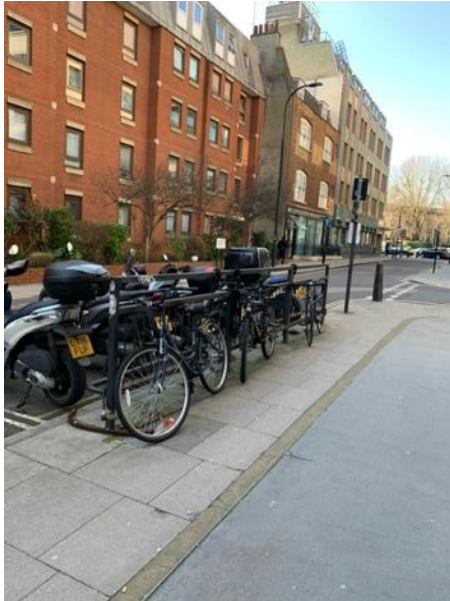
LOCATION: Corner of Cleveland Street and Warren Street.

ISSUE: Unnecessary guard railing, which is also being used as cycle parking. There also seems little need for the pole with one-way arrow sign; and the bollard.

The footway could be widening from the Warren Street junction south, potentially to include making permanent the Streaterie space. This would also provide opportunities for additional cycle parking, while improving conditions for pedestrians.

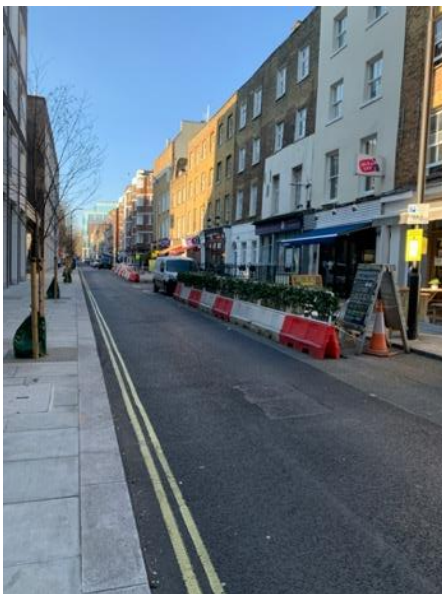
LOCATION: Grafton Way to Warren Street eastern side.

ISSUE: The streetscape in this location could be much enhanced with simple improvements to replicate the decluttered and tree-lined footway improvements on the Westminster side, potentially with loading pads, 'oasis spaces' for informal dwell and rest, and additional cycle parking.

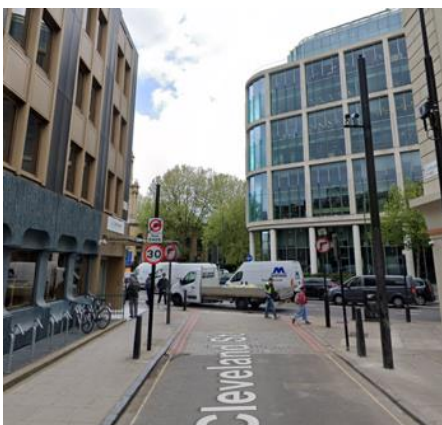
LOCATION: Junction with Euston Road.

ISSUE: Unnecessary bollards and signage poles, which can be rationalised and reduced in number.

Unnecessary poles: signage can be placed onto the CCTV camera pole or the final two posts at the junction.

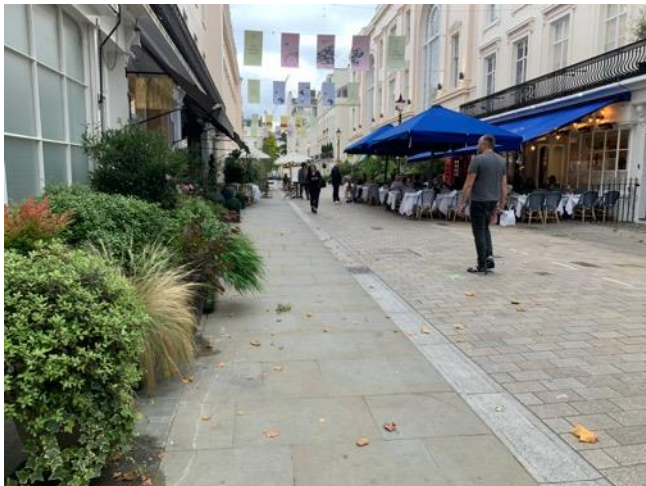
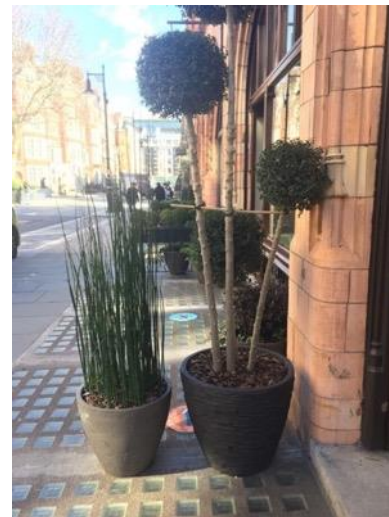
It was also observed that a significant proportion of the public realm on Cleveland Street is private forecourts, which are designed and maintained to varying standards, which detracts from the overall appearance of the street. These could be tidied and a planting design framework developed for their activation and to improve their appearance, for example as Grosvenor has done in Mayfair and Belgravia.
